**Assessment on the Development and Coastal Erosion along the Middle Coastline of
Terengganu**

Dissertation submitted in partial fulfillment of
the requirements for the
Bachelor of Engineering (Hons)
(Civil Engineering)

JULY 2009

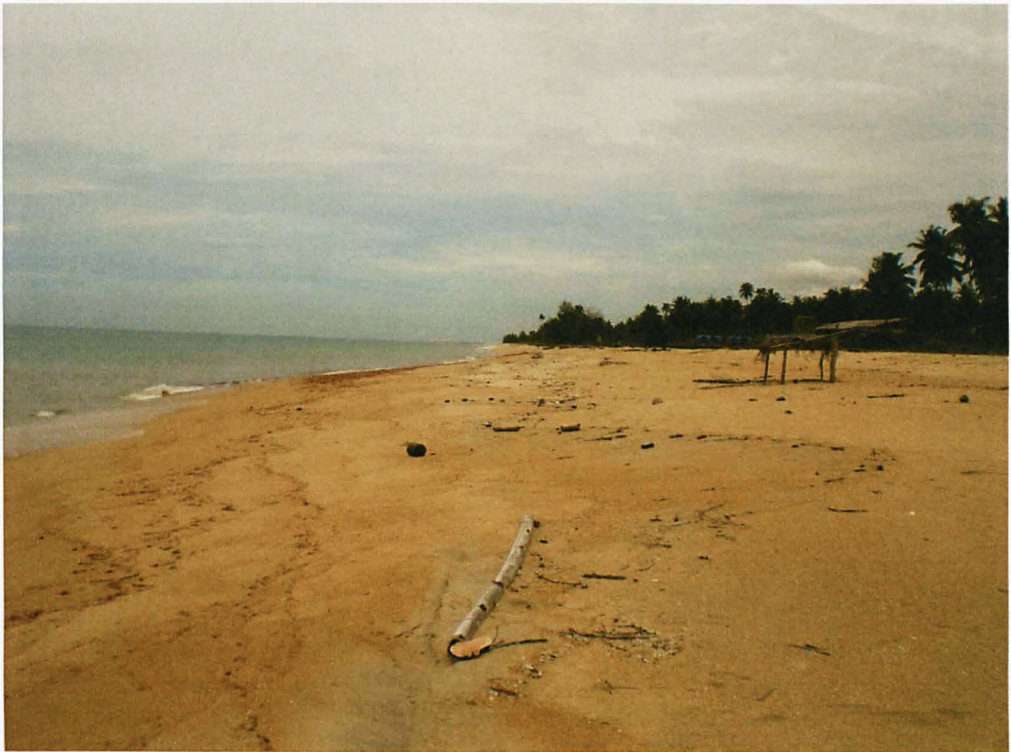
- Date/Day: 6th September 2009, Sunday
- Time: 1.30 PM
- Location: Batu Rakit
- Wind: Moderate
- Weather: Sunny
- Tide: Low tide
- Description: Well graded
- Length: 2.0 km
- Category: 3

Figure 4.2: Batu Rakit Beach

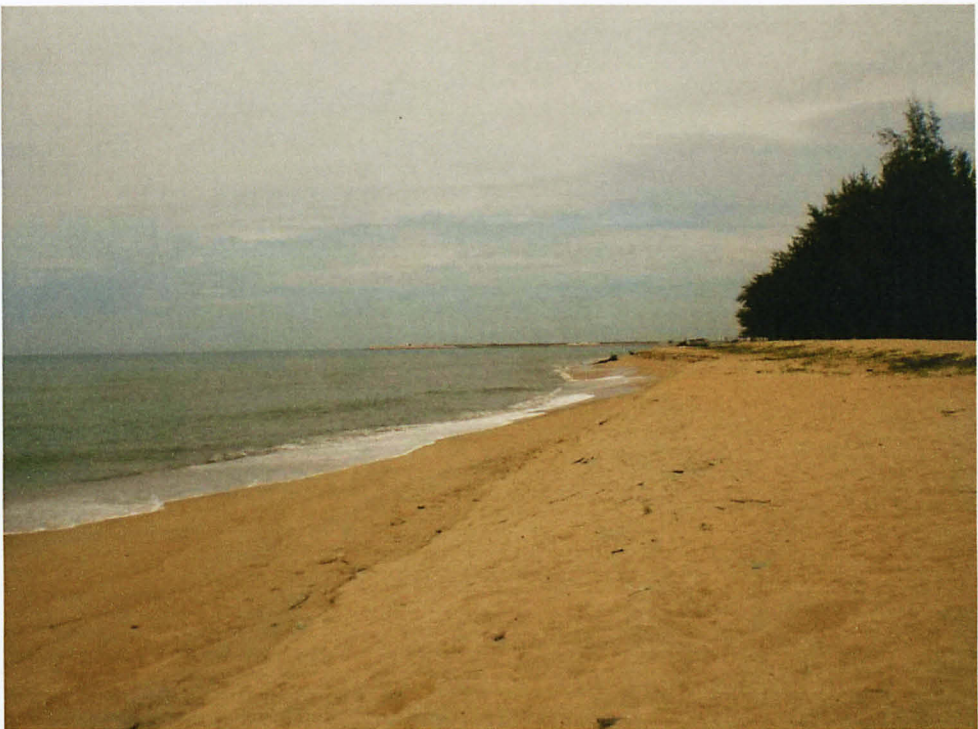
- Date/Day: 6th September 2009, Sunday
- Time: 1.00 PM
- Location: Kg Wakaf Tok Jembal
- Wind: Windy
- Weather: Sunny
- Tide: Low tide
- Description: Poorly graded
- Length: 1.0 km
- Category: 1

Figure 4.3: Tok Jembal Beach

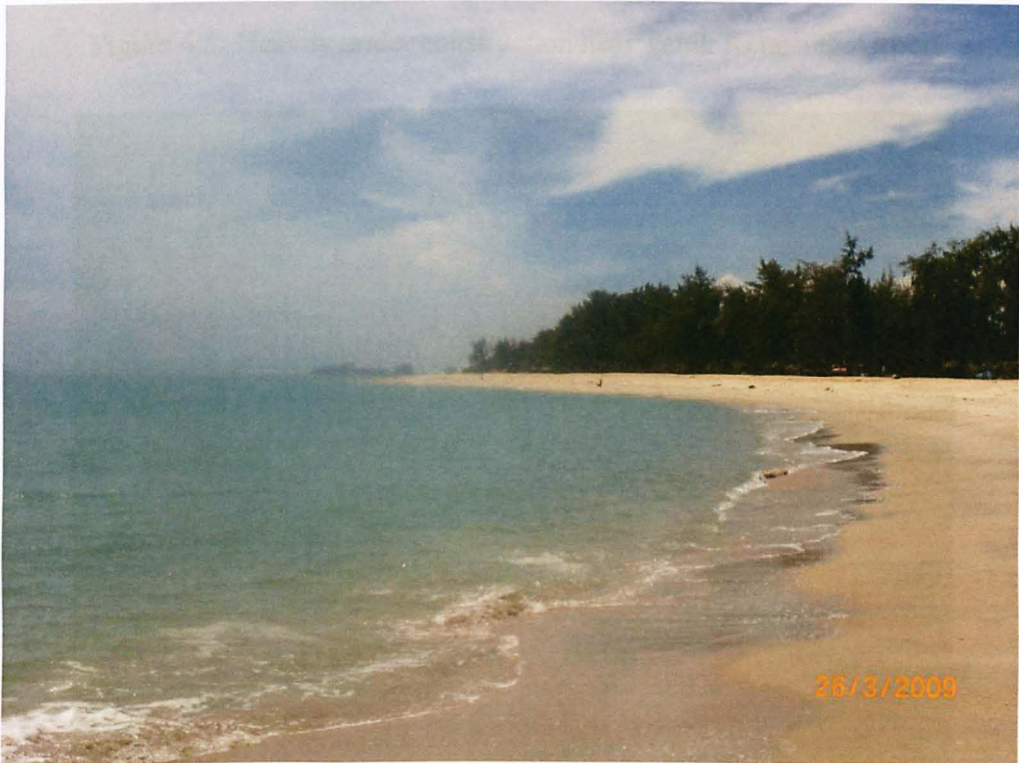
- Date/Day: 26th March 2009, Thursday
- Time: 12.15 PM
- Location: Teluk Ketapang
- Wind: Moderate
- Weather: Sunny
- Tide: Decrease to low tide
- Description: Well graded
- Length: 5.0 km
- Category: 3

Figure 4.4: Teluk Ketapang Beach

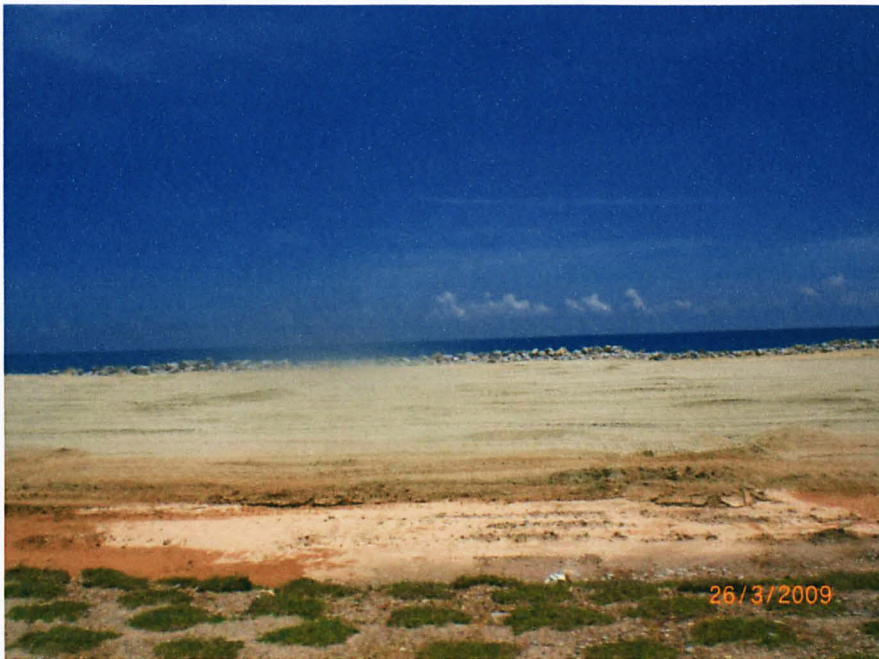
Figure 4.6: Revetment is under construction near Teluk Ketapang Airport

During the site visit to the Teluk Ketapang, the project is still on-going project. I have opportunity to meet the Project Manager, En Wan Mohd Kipin Wan Mohdun to tell briefly about the project. According to him, this area between Teluk Ketapang and Batu Puteh, the coastal is categorized as Category 1 which is very critical. The erosion is caused by the northern exposure but the southern side stabilized back the beach area. Thus the local authority is decided to construct the coastal erosion control in this area.

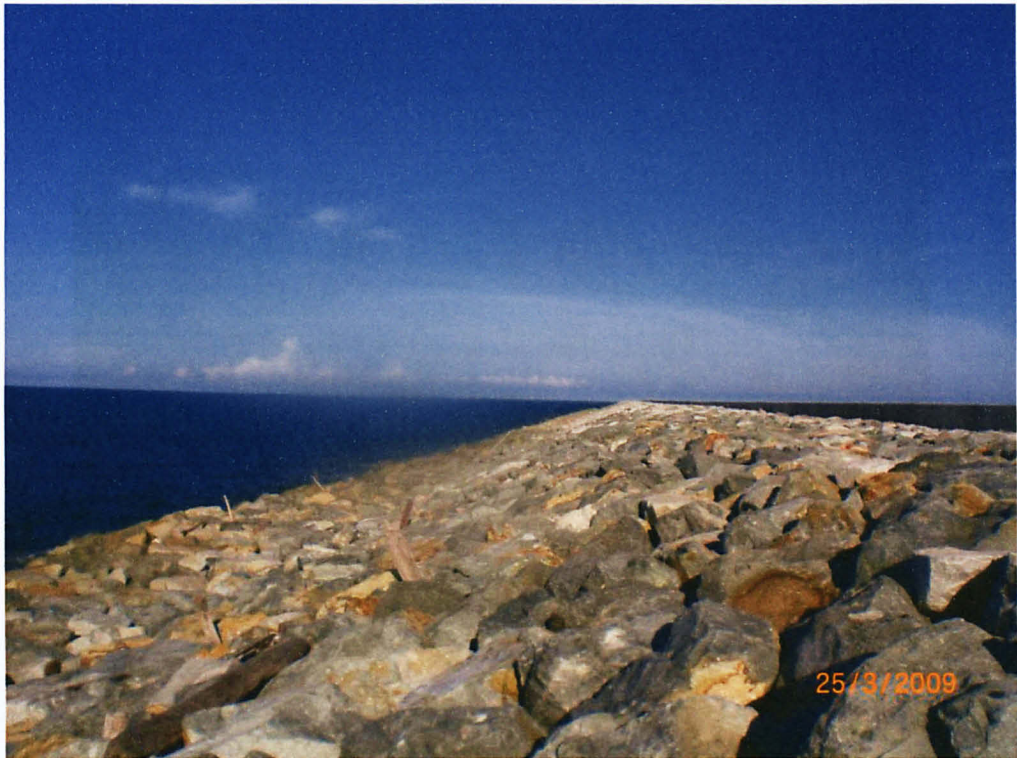
There are two breakwaters in this project which are North Breakwater and South Breakwater. The North Breakwater has length of 2345 m and the South Breakwater has length of 1115 m. this breakwater has the height of 6.75 m for the mean sea level. For the maximum high tide, these breakwaters are still more height than the maximum high tide. This breakwater used stones instead of using concrete-shaped boxes.

Figure 4.8: North Breakwater at Kuala Terengganu Rivermouth

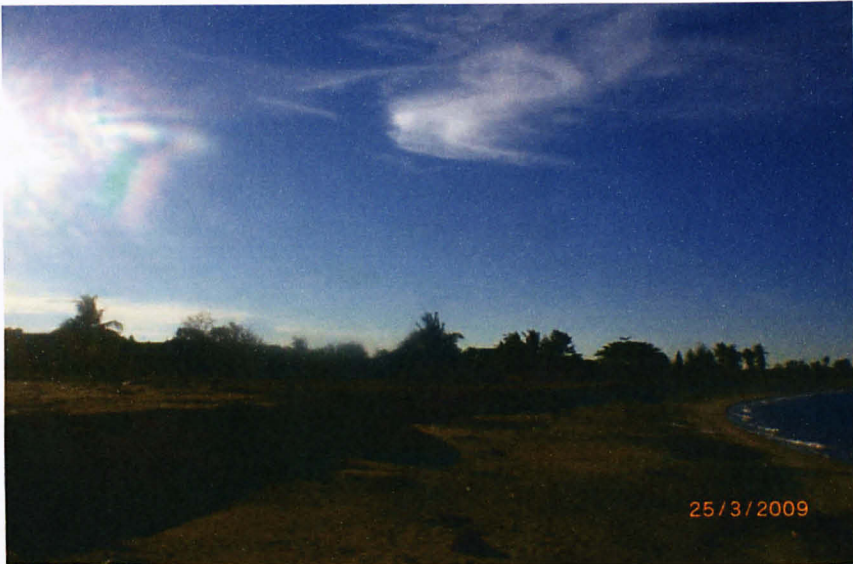
800 m of beach nourishment is in the planning located at the northern area while 5500 m at the southern area. According to En Wan, the 800 m of beach nourishment at northern area will not be built as the local authority (JPS) instructed not to do so. But, during the site visit to the area, some reclamation work is being done.

Figure 4.9: Beach nourishment that expected to be done at Northern area

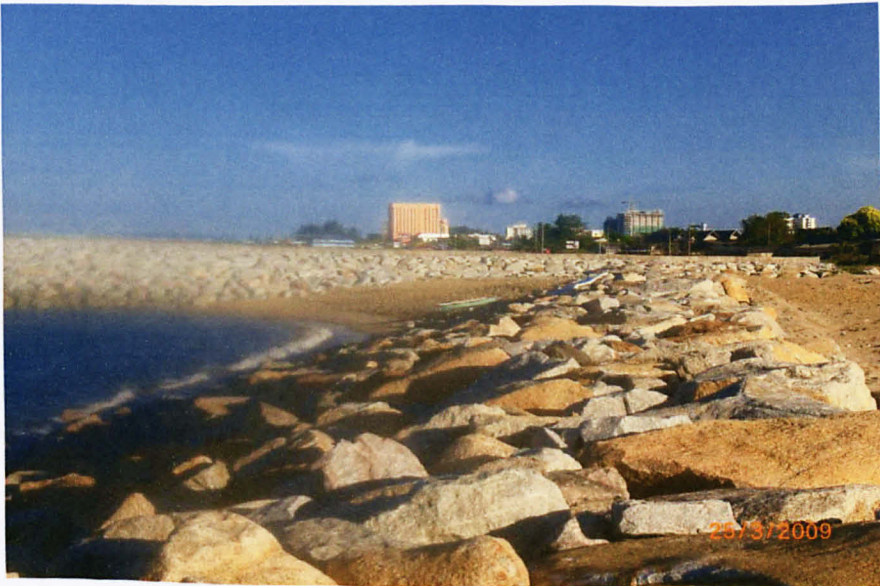
Figure 4.10: Revetment at the area that expected to have beach nourishment

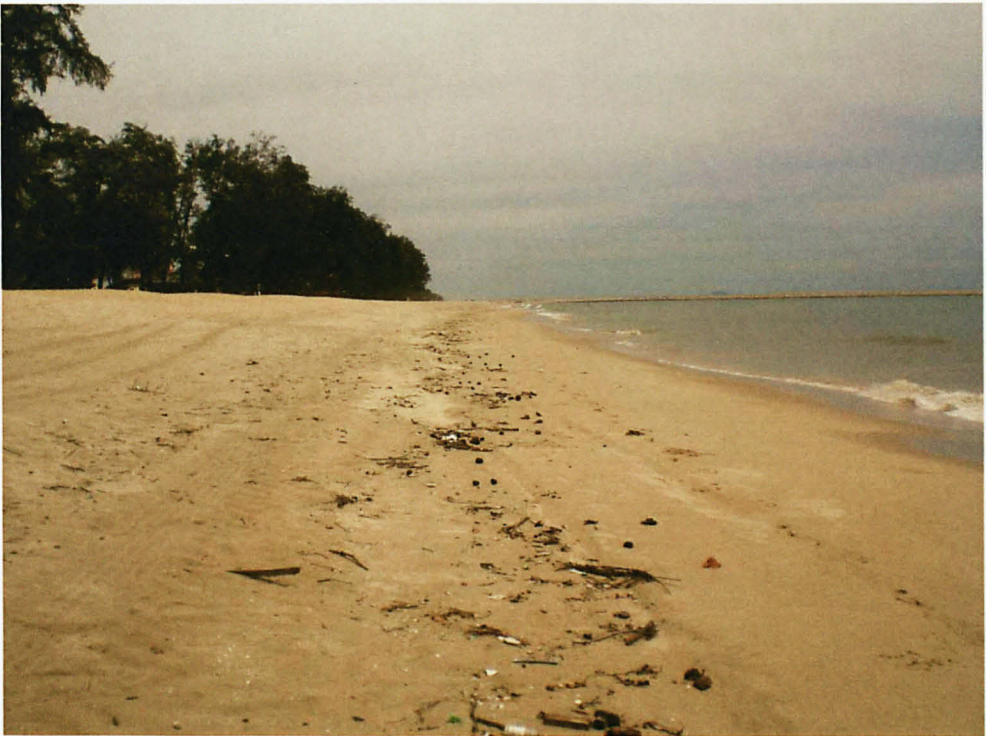
- Date/Day: 6th September 2009, Sunday
- Time: 12.30 PM
- Location: Kg. Pantai Batu Buruk
- Wind: Moderate
- Weather: Sunny
- Tide: Increase to be high tide
- Description: Poorly graded is considered
- Length: 6.0 km
- Category: 1

Figure 4.12: Beach condition at Batu Buruk Beach

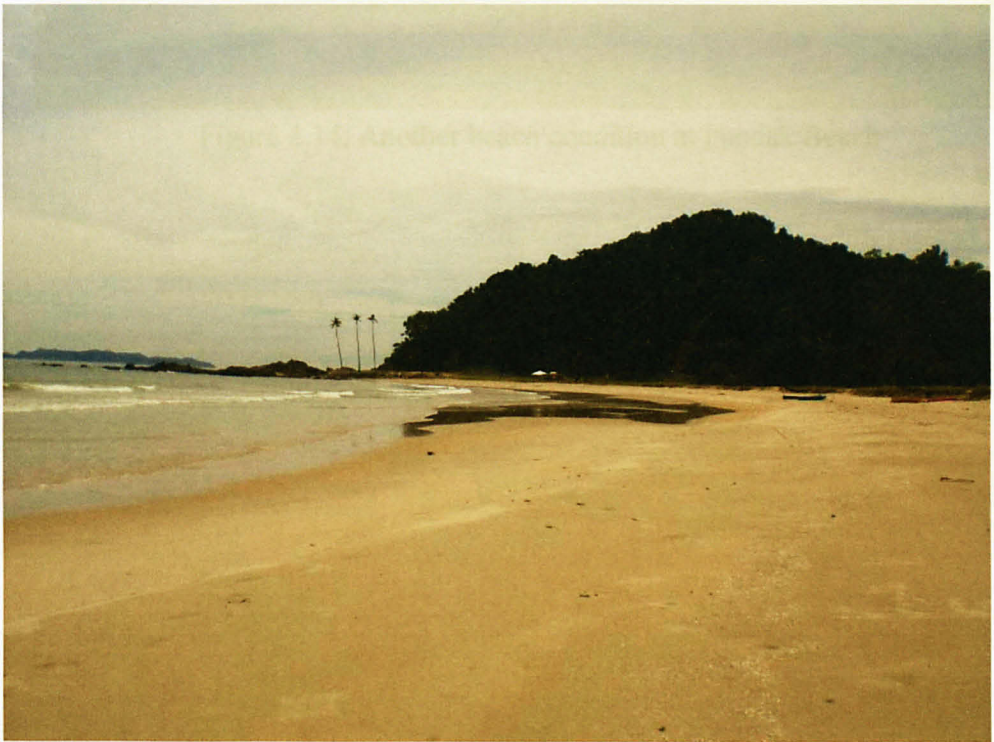
- Date/Day: 6th September 2009, Sunday
- Time: 12.20 PM
- Location: Near to Kg. Cenering
- Wind: No wind
- Weather: Sunny
- Tide: Low tide
- Description: Well graded
- Length: 2.0 km
- Category: 3

Figure 4.13: Beach condition at Pandak Beach

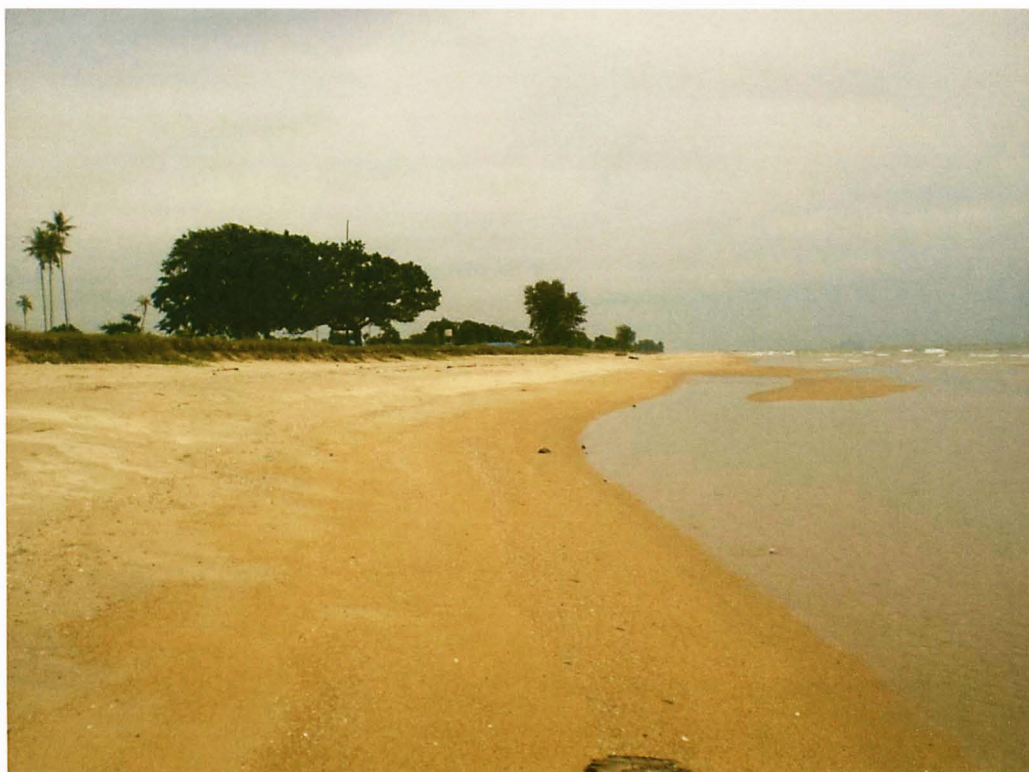
Figure 4.14: Another beach condition at Pandak Beach

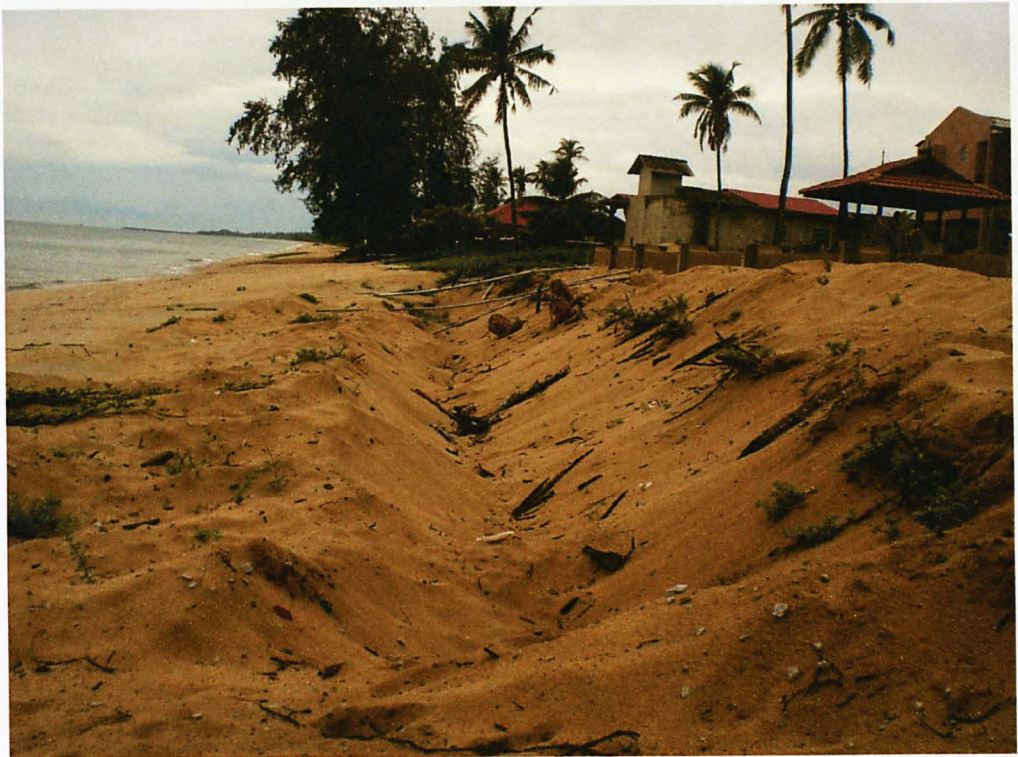
- Date/Day: 6th September 2009, Sunday
- Time: 12.00 PM
- Location: Kg. Rusila
- Wind: Windy
- Weather: Sunny
- Tide: Low tide
- Description: Well graded
- Length: 2.0 km
- Category: 1

Figure 4.15: Beach condition at Rusila Beach

From the result obtained, sand beach at Rusila is considered as well graded with the D_{50} is 0.32 mm to 0.7 mm. But from the site assessment with the aid of information from Drainage and Irrigation Department Kuala Terengganu, Rusila beach is considered as heavily having the erosion problem and it lays under category 1 which the drastic and comprehensive action and remediation should be taken to this beach. The length of beach which faces erosion problem is 2.0 km.

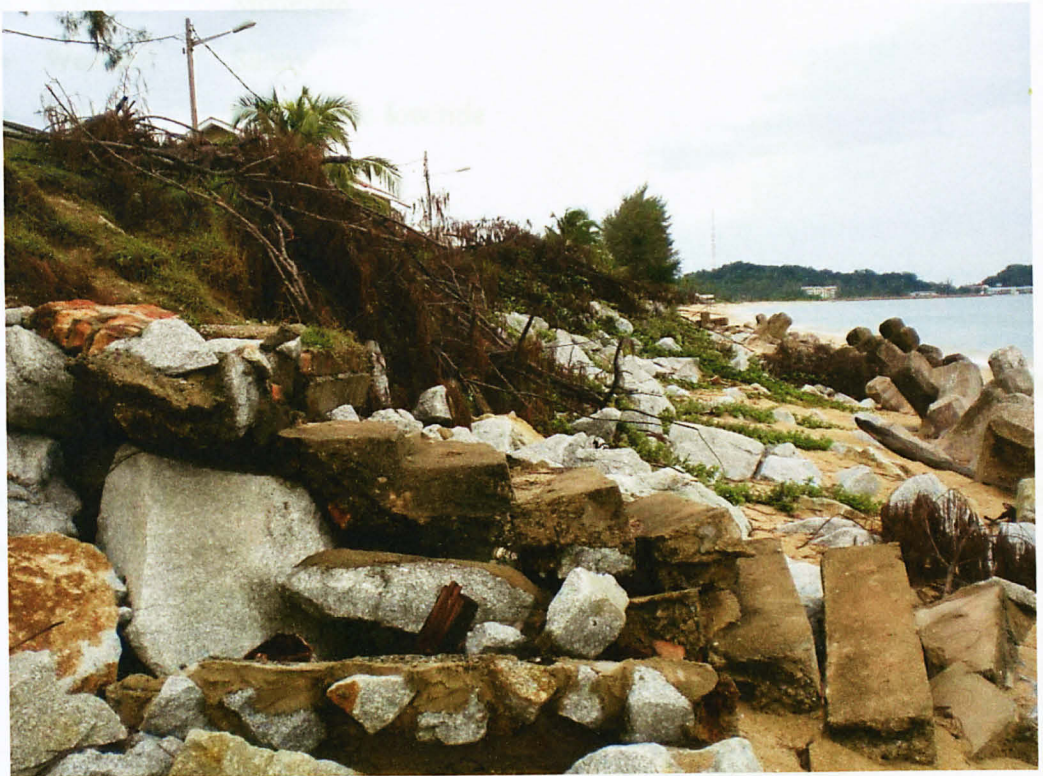
Figure 4.16: The concrete stairs is broken due to the erosion at Rusila Beach

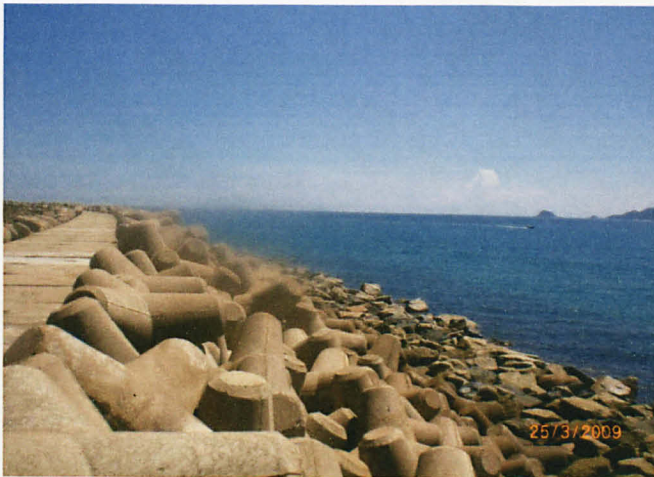
This breakwater is also to protect the rivermouth condition whereby to maintain the navigation of fishermen. According to villagers, during the northern monsoon, the wave is higher than the breakwater. This breakwater used concrete-shape instead of using stones.

Figure 4.17: Concrete Breakwater at Marang

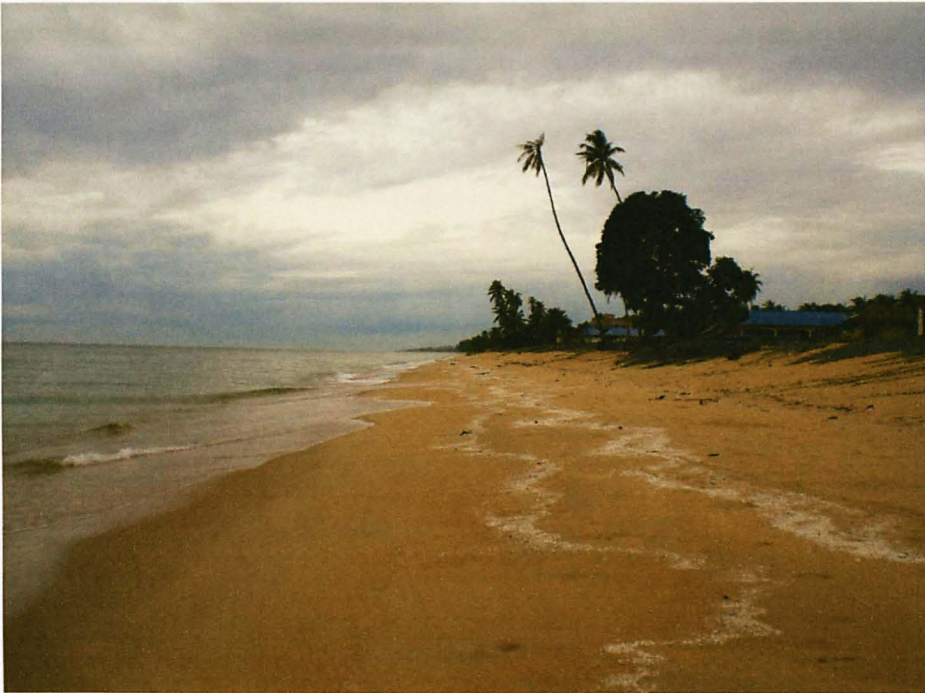
- Date/Day: 6th September 2009, Sunday
- Time: 11.40 AM
- Location: Kg. Rhu Muda
- Wind: Windy
- Weather: Sunny
- Tide: Low tide
- Description: Poorly graded
- Length: 2.0 km
- Category: 2

Figure 4.18: Beach condition at Rhu Muda

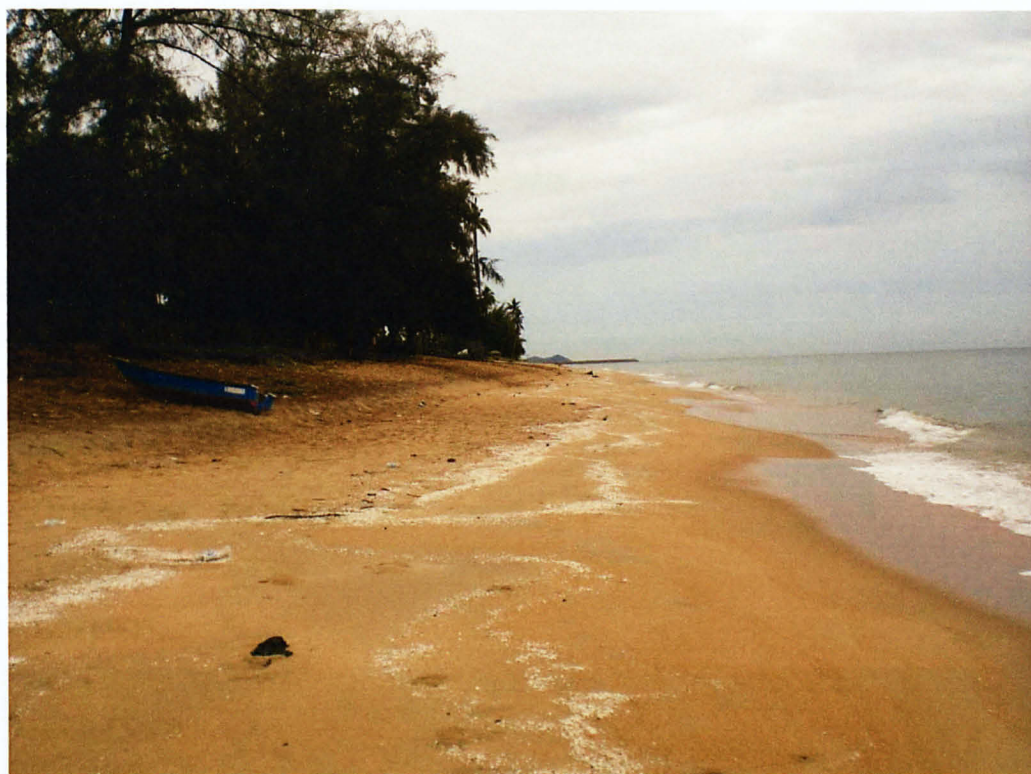
Figure 4.19: Another beach condition at Rhu Muda

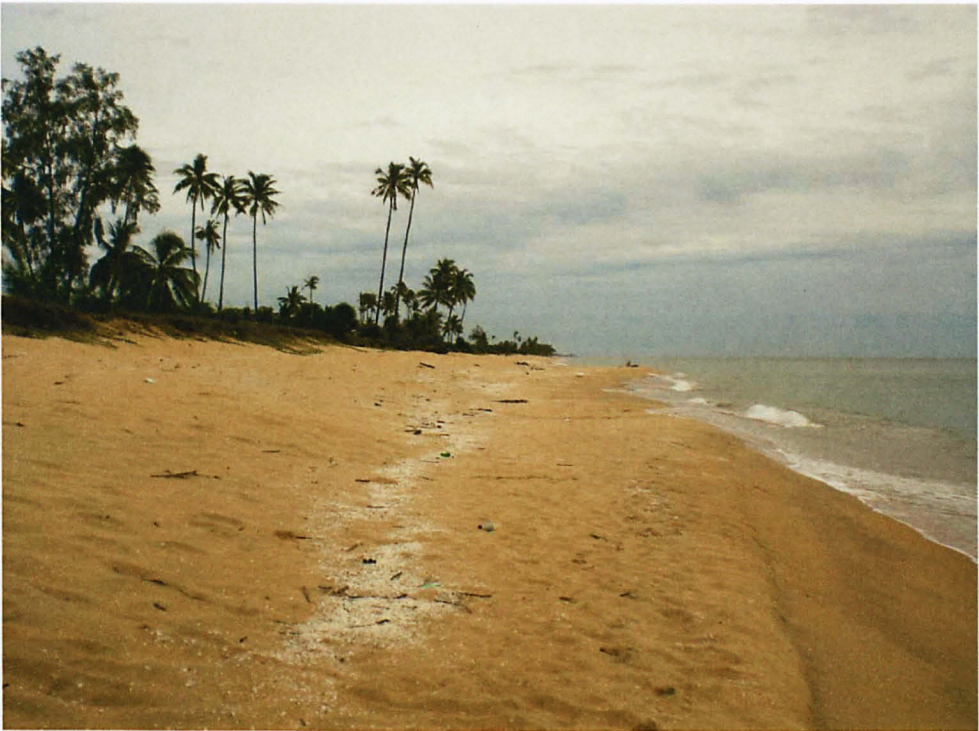
- Date/Day: 6th September 2009, Sunday
- Time: 11.25 AM
- Location: Kg. Pulau Kerengga
- Wind: Moderate
- Weather: Sunny
- Tide: Low tide
- Description: Poorly graded
- Length: 2.0 km
- Category: 2

Figure 4.20: Beach condition at Kerengga

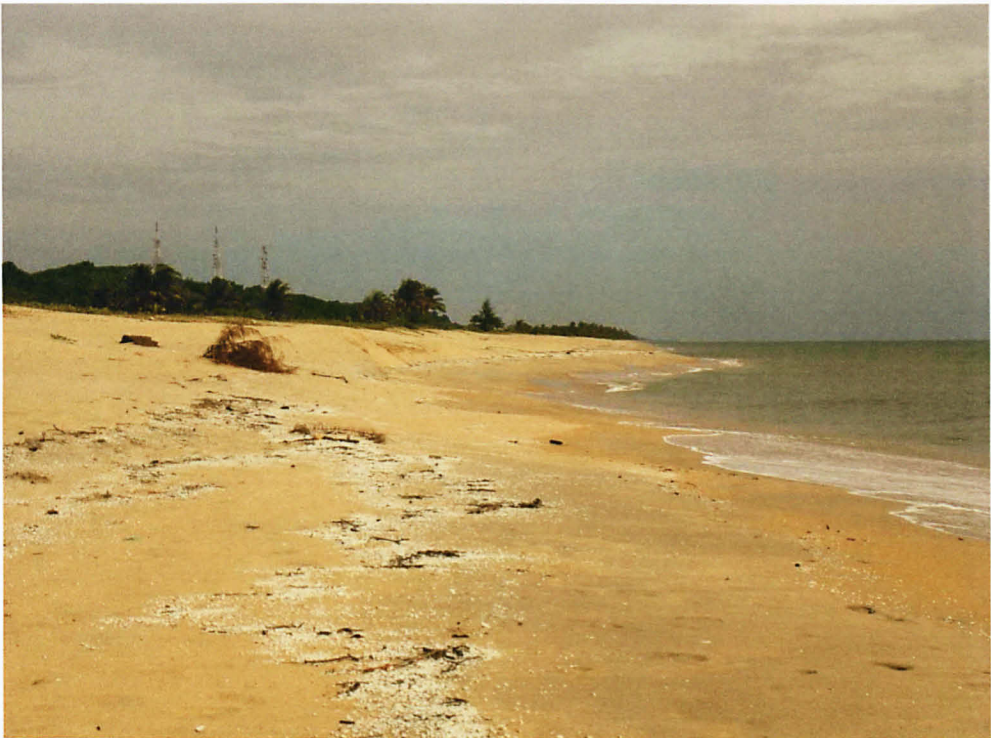
- Date/Day: 6th September 2009, Sunday
- Time: 11.10 AM
- Location: Kg. Merchang
- Wind: Moderate
- Weather: Sunny
- Tide: Low tide
- Description: Poorly graded
- Length: 3.0 km
- Category: 2

Figure 4.21: Beach condition at Kg. Merchang

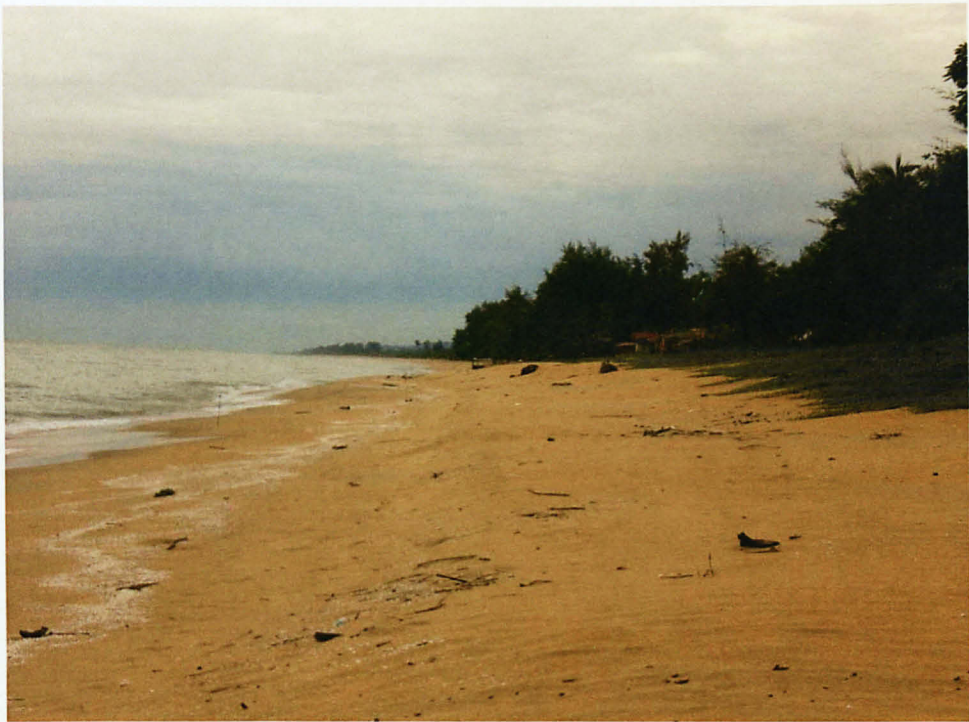
- Date/Day: 6th September 2009, Sunday
- Time: 10.40 AM
- Location: Kg. Pasir Putih
- Wind: Moderate
- Weather: Sunny
- Tide: Low tide
- Description: Well graded
- Length: 2.0 km
- Category: 2

Figure 4.22: Beach condition at Kg. Pasir Putih

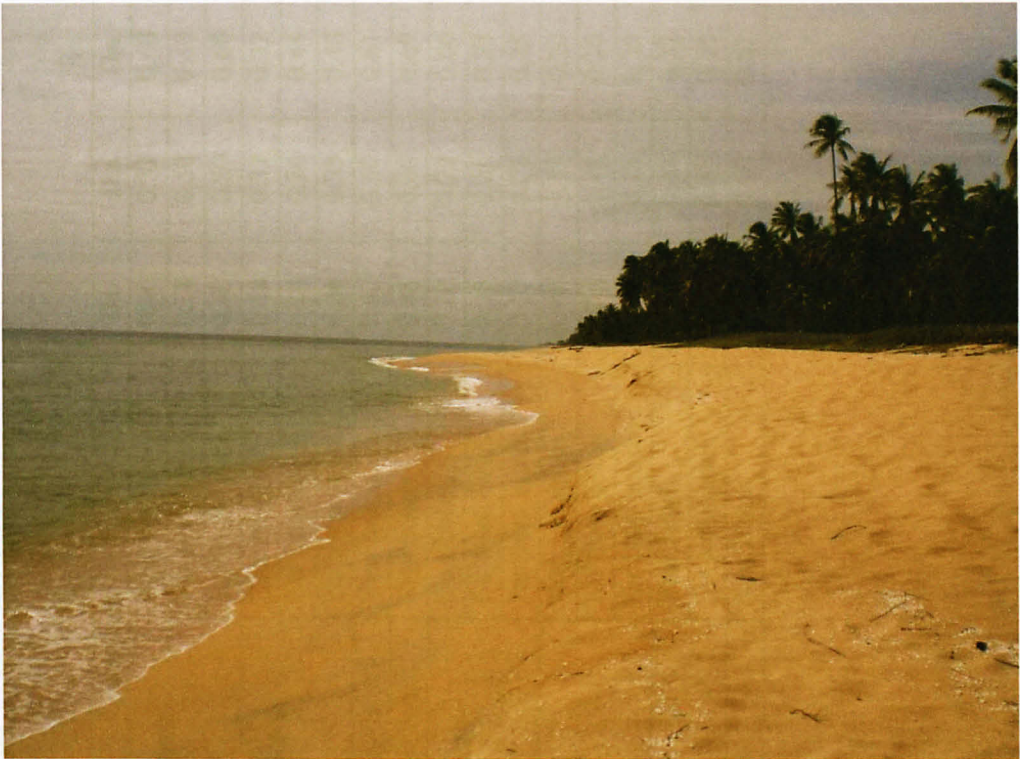
- Date/Day: 6th September 2009, Sunday
- Time: 10.10 AM
- Location: Kg. Jambu Bongkok
- Wind: Moderate
- Weather: Sunny
- Tide: Low tide
- Description: Well graded
- Length: 2.0 km
- Category: 3

Figure 4.23: Beach condition at Kg. Jambu Bongkok
